TREE REPORT

Santa Clara Square
Santa Clara CA

PREPARED FOR
Mindigo & Associates
1984 The Alameda
San Jose CA 95126

November, 2003

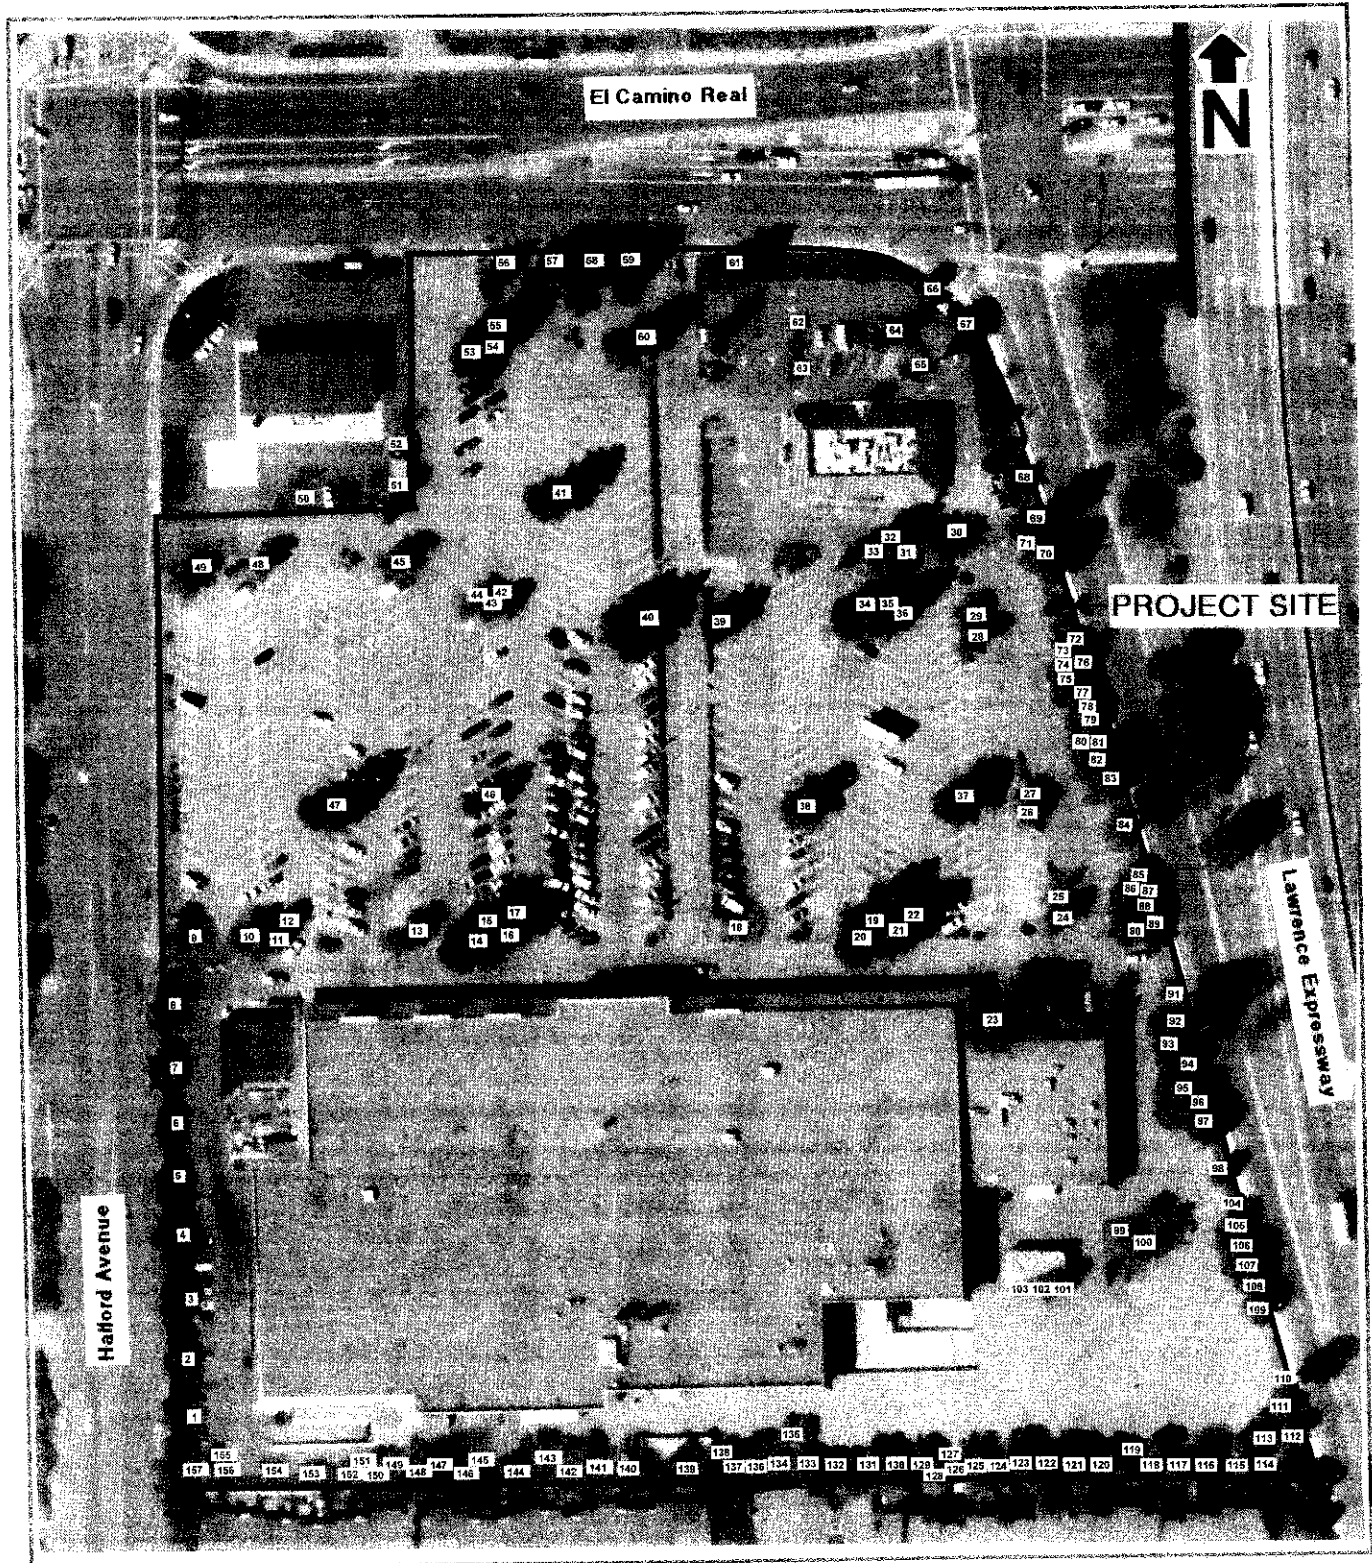
Tree Survey Map

One hundred fifty-seven trees were evaluated. Descriptions of each tree are found in the **Tree Survey** and locations are plotted on the **Tree Survey Map** (see Attachments). A summary is provided in Table 1.
